Incident Report

Date of Incident: 2019-12-28

HÁFJALL EHF. Dynjandi, 781 Hornafjörður, Iceland

Seriousness:	Accident – Observed / Rescue
Date of incident:	2019-12-28
Reported by	Stephan Mantler 011274-4559 (SM)
Tour leader	SM
Name of tour	Ice Cave Day Tour
Place of incident	Unnamed moulin on Breiðamerkurjökull (N [REDACTED]° W [REDACTED]°)

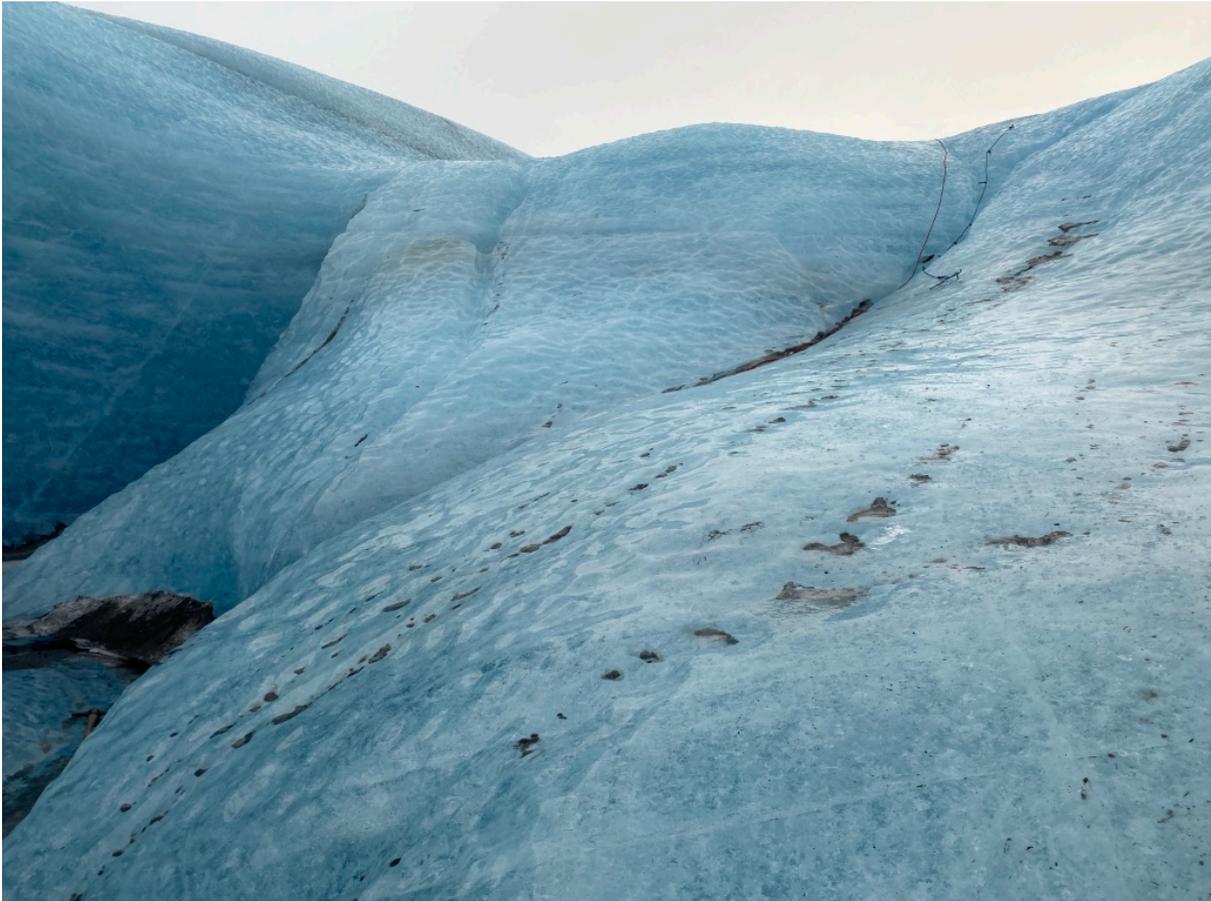
Incident site

Moulin from just above the casualty's location. Red rope ours in preparation for evacuation and roughly follows the suspected fall line. Blue rope was already present when I arrived.

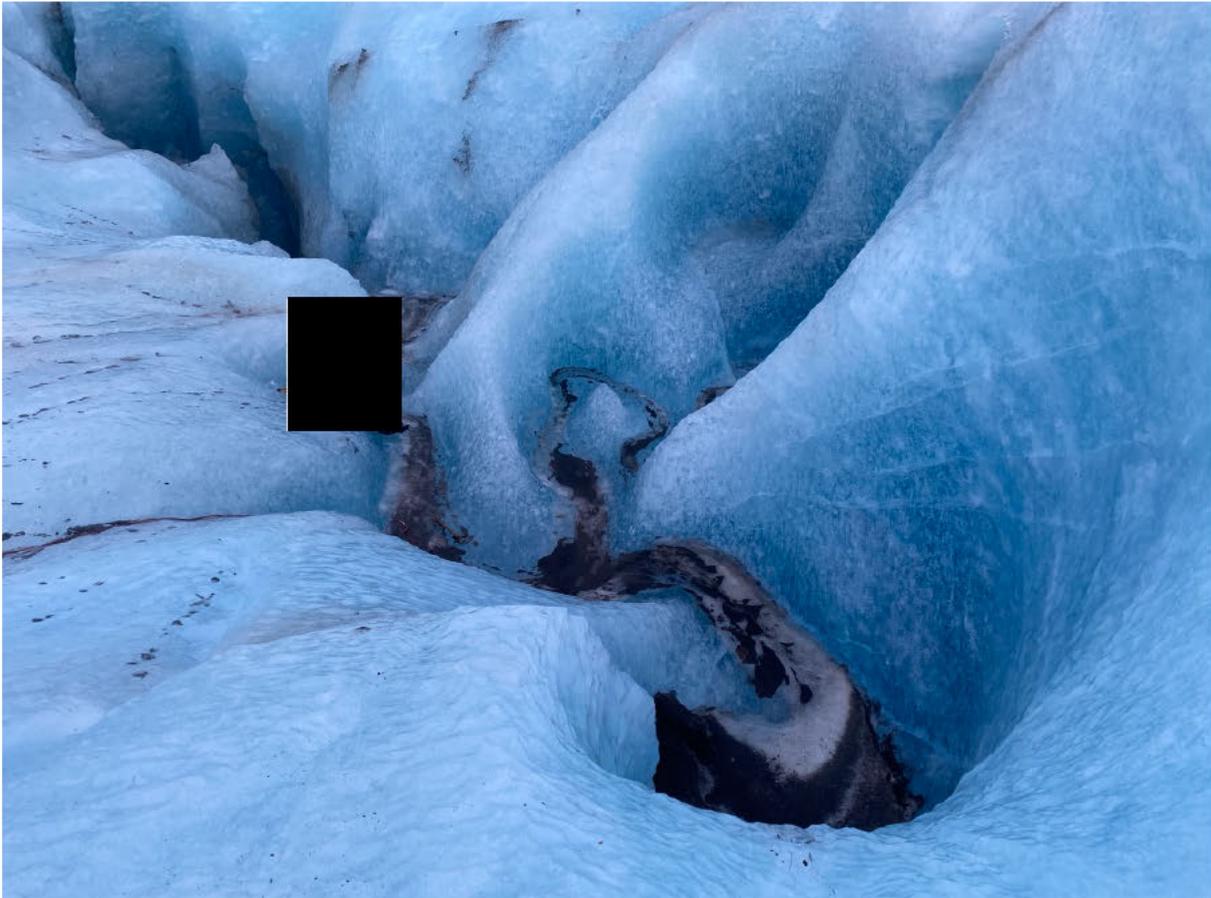
Looking down into moulin, standing on the flat ledge visible in the above image top center. Red rope enters center left. Note chopping axe just below. Impact evidence is visible just above the ice axe (see below and next image)

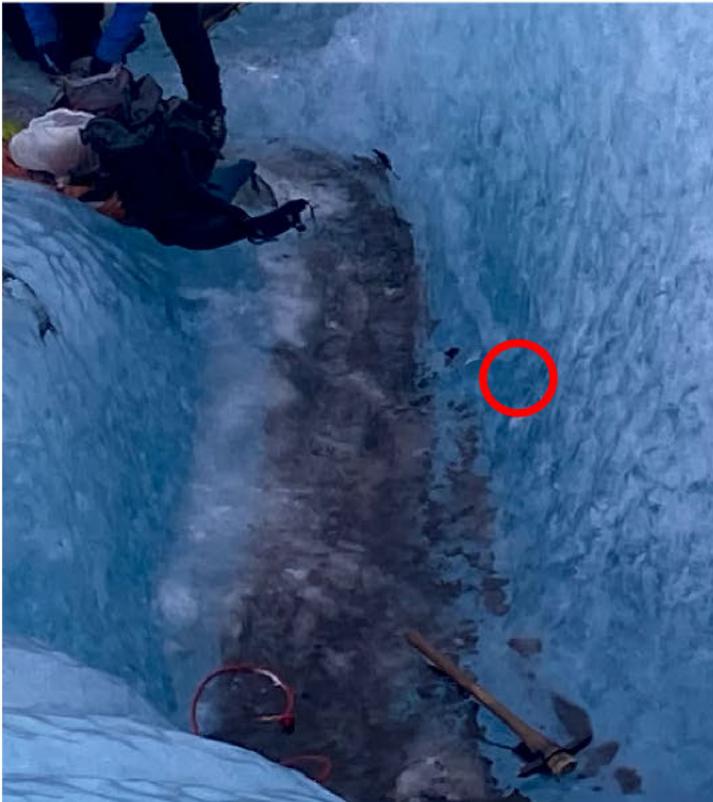
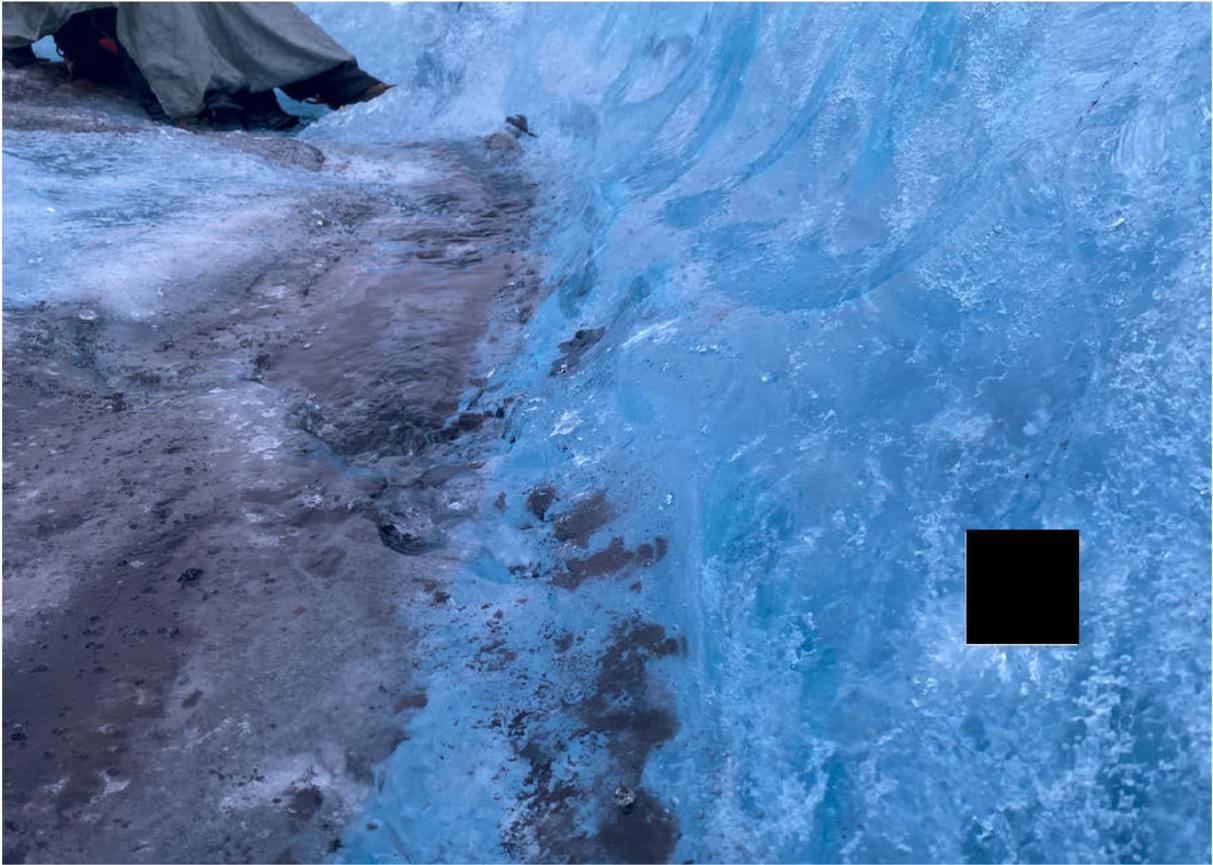
Impact evidence.
